Home Performance with Energy Star Report

HOMEOWNER:
John & Jane Smith

ADDRESS:
1234 Typical Home
Phoenix, AZ 85012

INSPECTION DATE:
8/2/2011

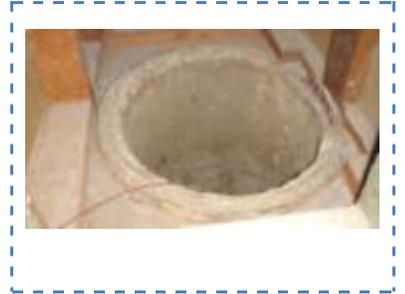
<u>Pressure Pan Readings</u>	(per system)	<u>Overall Duct Leakage</u>	<u>Ducts are:</u>
Supplies 0.2 to 1.1		430 CFM50	Leaky in Need of Sealing
Return(s) 1.9 to 2.6

Why is this important? *As much as 1/3 of your home's expensive conditioned air may be leaking into or being pulled from to the attic or other unwanted areas through cracks or poorly fitting duct connections. In addition, to increasing utility bills, indoor air may be contaminated with pollen, exhaust fumes, or other hazards.*

1. **Seal boot to drywall for all supplies.**
2. **Seal (4) floor returns open to attic space and supply & return plenums.**
3. **Wrap exposed rigid duct work with R-4 insulation.**
4. **Homeowner to utilize 30 day high flow filters**

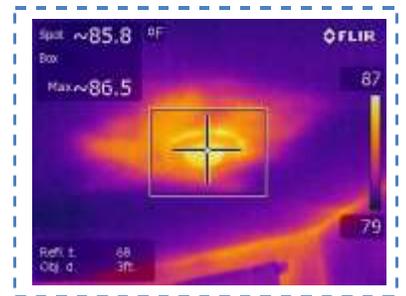
Insulation type: **Blown Cellulose**

Average Depth: **4 inches**

Overall Installation quality: **Average, small gaps, voids, etc.** → Effective R-value: **14.8**

1. **Blow entire attic to R-38. Add (R-25), appx. 1500 sq. ft.**
2. **Blow to cover all exposed duct work.**
